INTERAGENCY STATE
BURNED AREA EMERGENCY RESPONSE
(BAER) REPORT

THE POOMACHA FIRE

Affecting watersheds in the
County of San Diego
CALIFORNIA

November 17, 2007

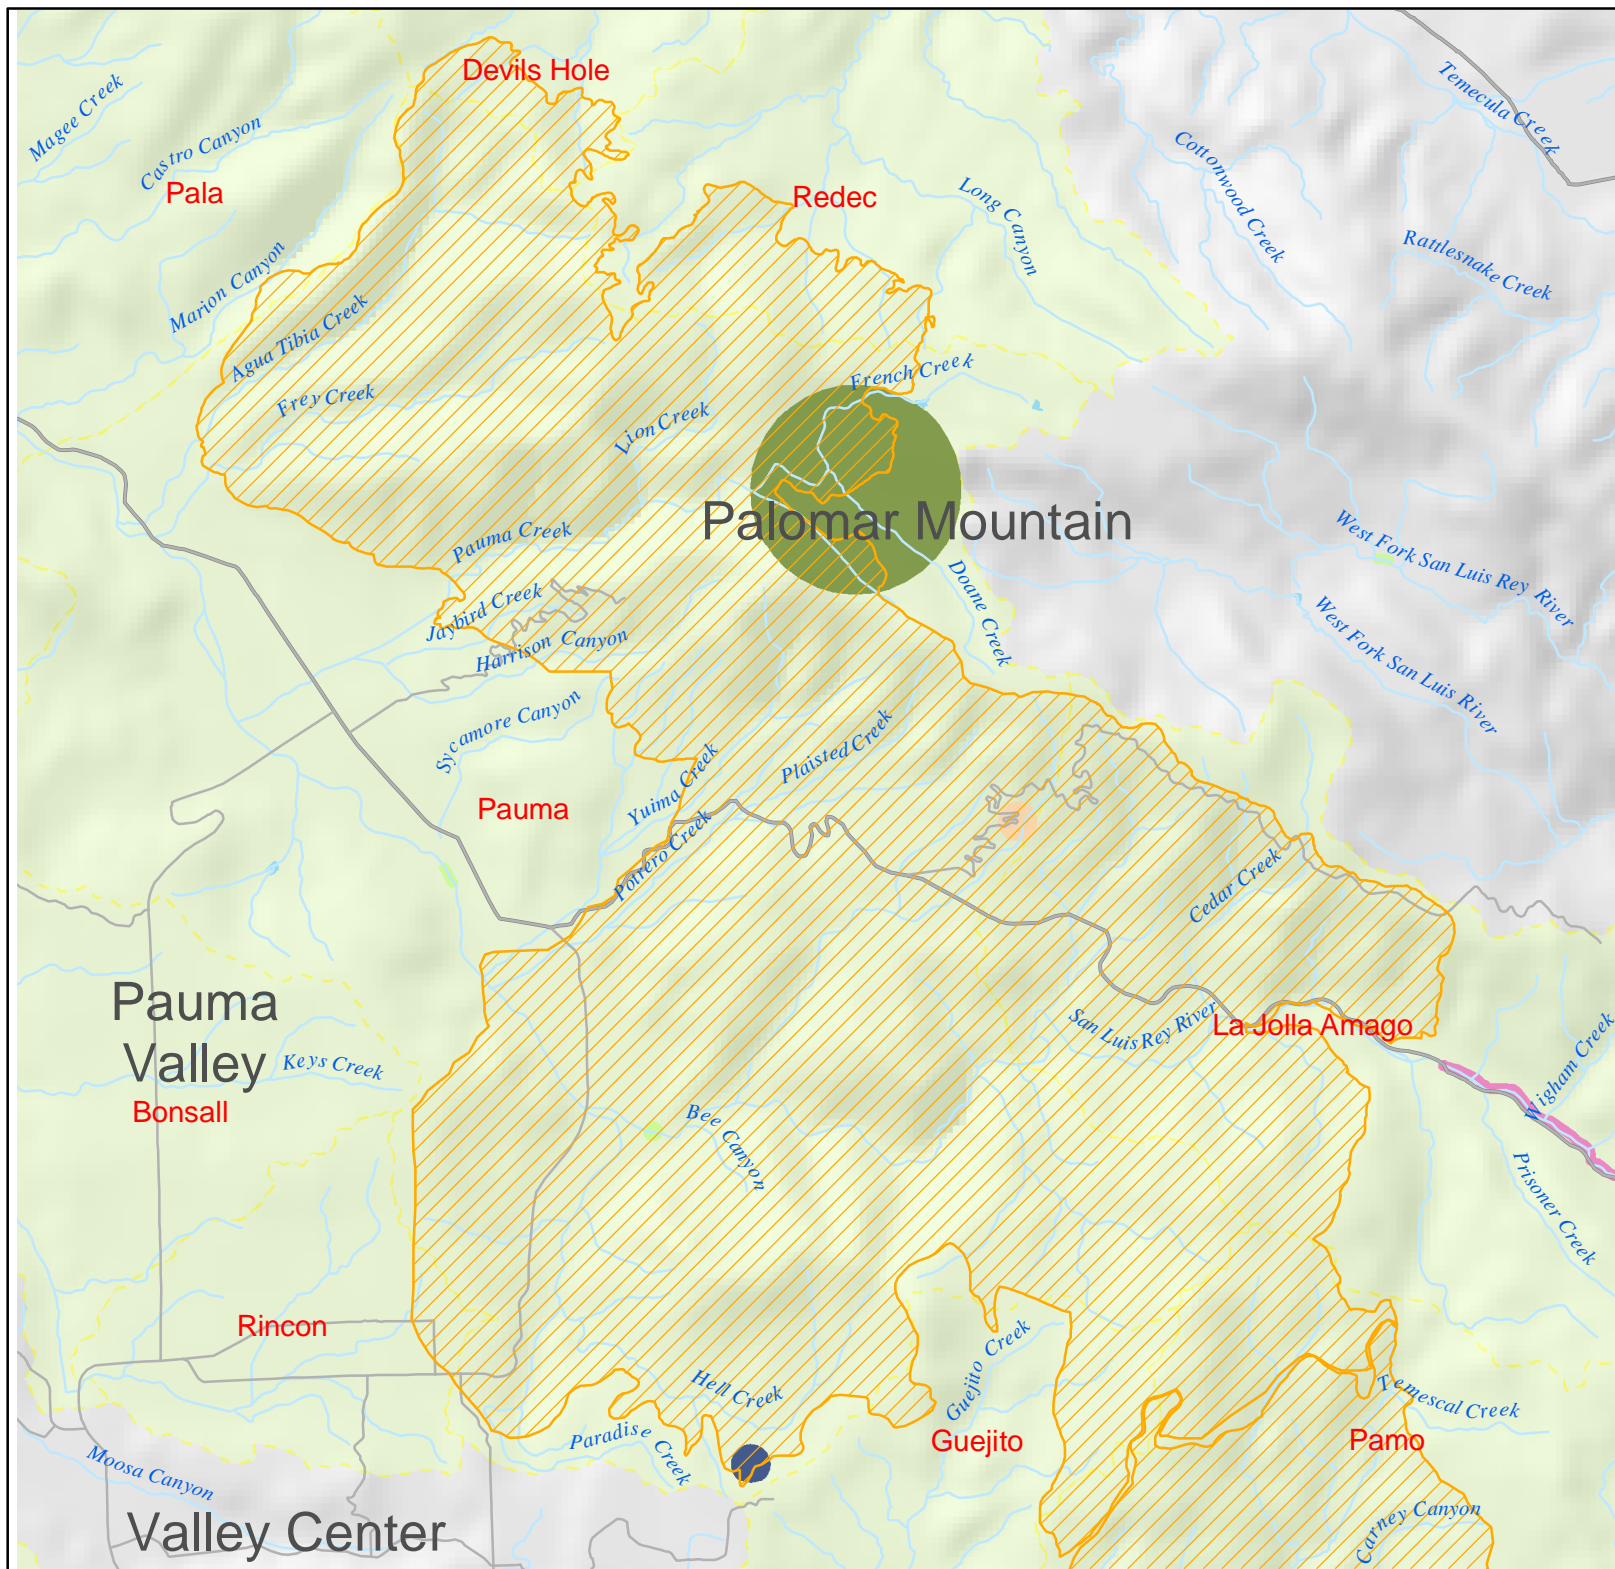
VEGETATION IMPACTS INCIDENT CA-MVU-010634 POOMACHA FIRE 10/31/2007 0600

- Fire Perimeter (071031)
- Vegetation Communities (Holland 95 Classification)**
- HOLLAND**
- Southern Foredunes, Beach, Saltpan, Mudflats
- Coastal Sage Scrub
- Chaparral
- Grassland
- Riparian Scrub
- Riparian Woodland
- Riparian Forest
- Pinyon Juniper Woodlands
- Other Woodlands
- Oak Forest
- Meadow and Seep
- Marsh
- Coniferous Forest
- Desert Dunes (22100, 22300)
- Playas/Badlands/Mudhill Forbs
- Desert Scrub
- Desert Chaparral
- Dry Wash Woodla
- Water (Including 11200, 13200)
- Urban, Disturbed Habitat, Agriculture, Eucalyptus Woodland
- Not Mapped (data gaps)
- Parcels
- Thomas Bros. Grid Page
- Highway
